Manhole Inspection Summary

Manhole # S05YY1001MH

Insp Date: **9/7/06 8:44 AM**

Location Address: **5901 WINNER AVE**

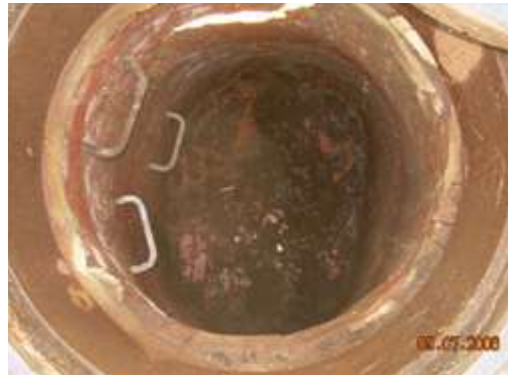
Top View

Frame leaks. Adjustment deterioration and loose brick. Adjustment, Corbel, and Barrel infiltration. Corroded steps.

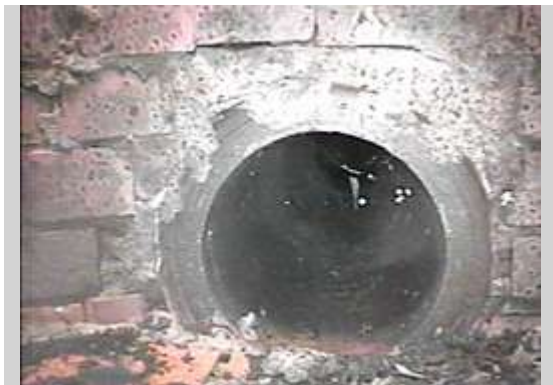
Pipe Out @ 12 O'Clock

Infiltration: **Evidence**
